**Flood Control Project Maintenance
Levee Inspections**

Maintenance Issue Types Only, Levee Inspection Report By Mile - Spring 2019

Reclamation District No. 2068 Yolo

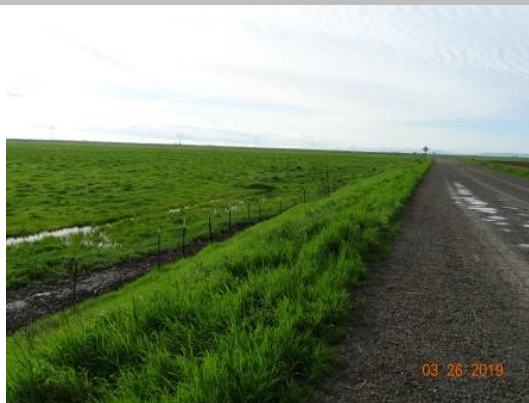
Photo 1 of 1 : SP_2019_RD2068_193_9_20190329_00020.jpg

LM Start	0.51	Rating **	M	Issue No.	9
LM End	2.50	Issue Type +	Ma	Location *	WS
Category	Earthen Levee			GPS Latitude/Longitude	
				Start	End
Item	Vegetation			38.401237 °	38.372257 °
				-121.693808 °	-121.693967 °
DWR ID	DWR_RD2068_01_s_2019_9				
Comment Code					
V1 : Control annual grass and weeds on the levee slopes and easements.					
Inspector Comment					
Maintain annual vegetation on the waterside slope.

View looking downstream at annual vegetation on the waterside slope (Spring 2019).

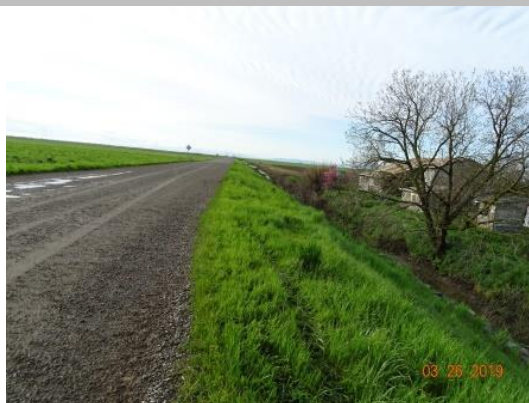
Photo 1 of 1 : SP_2019_RD2068_193_10_20190329_00021.jpg

LM Start	0.51	Rating **	M	Issue No.	10
LM End	2.50	Issue Type +	Ma	Location *	LS
Category	Earthen Levee			GPS Latitude/Longitude	
				Start	End
Item	Vegetation			38.401237 °	38.372257 °
				-121.693808 °	-121.693967 °
DWR ID	DWR_RD2068_01_s_2019_10				
Comment Code					
V1 : Control annual grass and weeds on the levee slopes and easements.					
Inspector Comment					
Maintain annual vegetation on the landside slope.

View looking downstream at annual vegetation on the landside slope (Spring 2019).

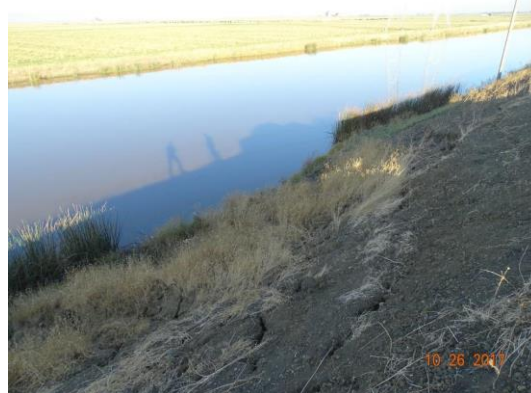
Photo 1 of 2 : SP_2019_RD2068_193_20_20190311_00001.jpg

LM Start	3.16	Rating **	A/W	Issue No.	20
LM End	3.19	Issue Type +	Ma	Location *	LS
Category	Earthen Levee			GPS Latitude/Longitude	
				Start	End
Item	Slope Stability			38.362765 °	38.362278 °
				-121.694040 °	-121.694050 °
DWR ID	DWR_RD2068_01_f_2018_20				
Comment Code					
S1 : Repair slope instability.					
Inspector Comment					
Repair the slope instability.

View of slope instability on the landside.

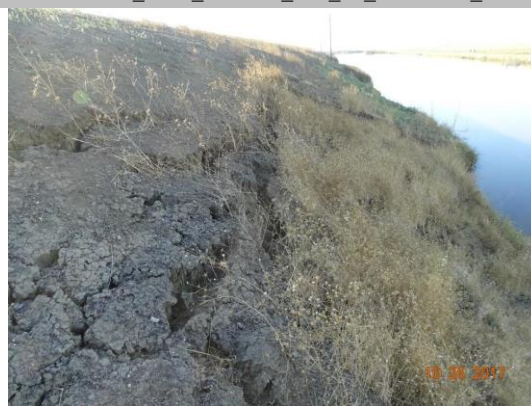
Photo 2 of 2 : SP_2019_RD2068_193_20_20190311_00002.jpg

LM Start	3.16	Rating **	A/W	Issue No.	20 (cont)	
LM End	3.19	Issue Type +	Ma	Location *	LS	
Category	Earthen Levee			GPS Latitude/Longitude		
				Start		End
Item	Slope Stability			38.362765 °		38.362278 °
				-121.694040 °		-121.694050 °
DWR ID	DWR_RD2068_01_f_2018_20					
Comment Code						
S1 : Repair slope instability.						
Inspector Comment						
Repair the slope instability.

View of the slope instability.

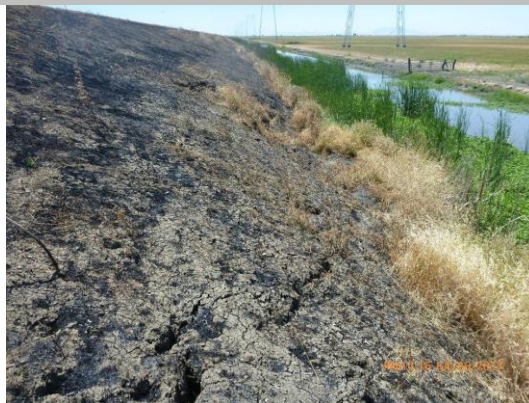
Photo 1 of 3 : SP_2019_RD2068_193_27_20190311_00003.jpg

LM Start	3.73	Rating **	A/W	Issue No.	27
LM End	3.74	Issue Type +	Ma	Location *	LS
Category	Supplemental			GPS Latitude/Longitude	
				Start	End
Item	2017 Storm Damage			38.354500 °	38.354400 °
				-121.694000 °	-121.694000 °
DWR ID	DWR_RD2068_01_f_2017_27				
Comment Code					
Inspector Comment					
Levee Evaluation Comments					
Description:The damage consists of scour, cracking, and sloughing of the lower landside levee slope approximately 47 feet in length along the west (right) bank of Shag Slough (Yolo Bypass). See attached pages for photos.					
Site ID No:462					
Site Designation:LMA-289					
Repair Type: Stability					
Rating:Serious					
Field Date:7/26/2017					
Notes: 2' feet vertical cut on waterside levee toe from wavewash; site combined with LMA- 288 in field.

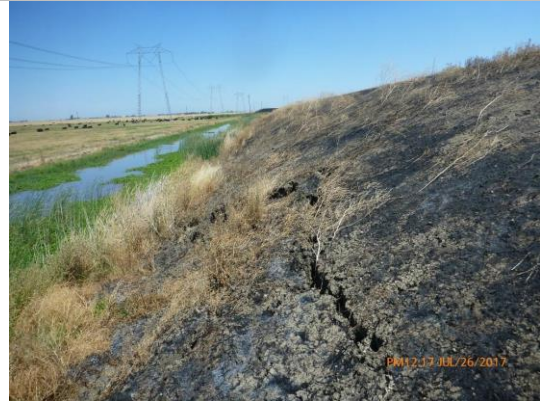
Photo 3 of 3 : SP_2019_RD2068_193_27_20190311_00005.jpg

LM Start	3.73	Rating **	A/W	Issue No.	27 (cont)	
LM End	3.74	Issue Type +	Ma	Location *	LS	
Category	Supplemental			GPS Latitude/Longitude		
				Start	End	
Item	2017 Storm Damage			38.354500 °	38.354400 °	
				-121.694000 °	-121.694000 °	
DWR ID	DWR_RD2068_01_f_2017_27					
Comment Code						
Inspector Comment						
Levee Evaluation Comments						
Description:The damage consists of scour, cracking, and sloughing of the lower landside levee slope approximately 47 feet in length along the west (right) bank of Shag Slough (Yolo Bypass). See attached pages for photos.						
Site ID No:462						
Site Designation:LMA-289						
Repair Type: Stability						
Rating:Serious						
Field Date:7/26/2017						
Notes: 2' feet vertical cut on waterside levee toe from wavewash; site combined with LMA- 288 in field.

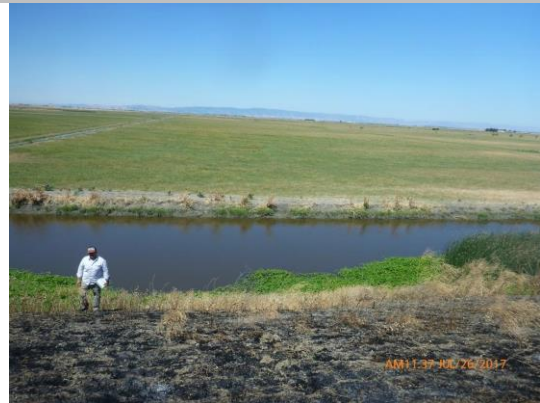
Photo 1 of 3 : SP_2019_RD2068_193_28_20190311_00006.jpg

LM Start	4.30	Rating **	A/W	Issue No.	28
LM End	4.31	Issue Type +	Ma	Location *	LS
Category	Supplemental			GPS Latitude/Longitude	
				Start	End
Item	2017 Storm Damage			38.346200 °	38.346100 °
				-121.694000 °	-121.694000 °
DWR ID	DWR_RD2068_01_f_2017_28				
Comment Code					
Inspector Comment					
Levee Evaluation Comments					
Description: The damage consists of scour, cracking, and sloughing of the lower landside levee slope approximately 30 feet in length along the west (right) bank of Shag Slough (Yolo Bypass). See attached pages for photos.					
Site ID No:463					
Site Designation:LMA-290					
Repair Type: Stability					
Rating:Serious					
Field Date:7/26/2017					
Notes: 3' feet vertical cut at waterside levee toe from wavewash

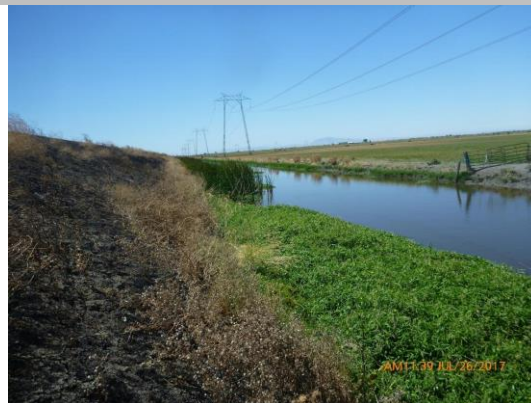
Photo 2 of 3 : SP_2019_RD2068_193_28_20190311_00007.jpg

LM Start	4.30	Rating **	A/W	Issue No.	28 (cont)
LM End	4.31	Issue Type +	Ma	Location *	LS
Category	Supplemental			GPS Latitude/Longitude	
				Start	End
Item	2017 Storm Damage			38.346200 °	38.346100 °
				-121.694000 °	-121.694000 °
DWR ID	DWR_RD2068_01_f_2017_28				
Comment Code					
Inspector Comment					
Levee Evaluation Comments					
Description:The damage consists of scour, cracking, and sloughing of the lower landside levee slope approximately 30 feet in length along the west (right) bank of Shag Slough (Yolo Bypass). See attached pages for photos.					
Site ID No:463					
Site Designation:LMA-290					
Repair Type: Stability					
Rating:Serious					
Field Date:7/26/2017					
Notes: 3' feet vertical cut at waterside levee toe from wavewash

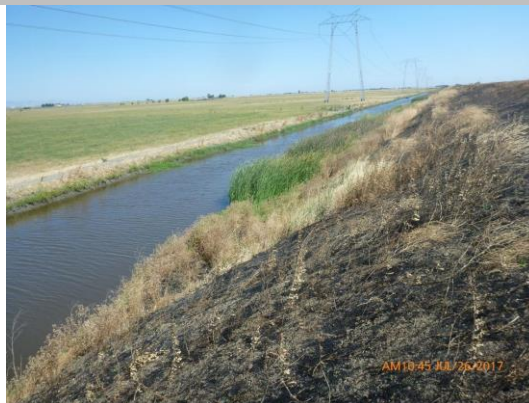
Photo 1 of 3 : SP_2019_RD2068_193_29_20190311_00009.jpg

LM Start	4.39	Rating **	A/W	Issue No.	29
LM End	4.40	Issue Type +	Ma	Location *	LS
Category	Supplemental			GPS Latitude/Longitude	
				Start	End
Item	2017 Storm Damage			38.344900 °	38.344800 °
				-121.694000 °	-121.694000 °
DWR ID	DWR_RD2068_01_f_2017_29				
Comment Code					
Inspector Comment					
Levee Evaluation Comments					
Description:The damage consists of scour, cracking, and sloughing of the lower landside levee slope approximately 30 feet in length along the west (right) bank of Shag Slough (Yolo Bypass). See attached pages for photos.					
Site ID No:464					
Site Designation:LMA-291					
Repair Type: Stability					
Rating:Serious					
Field Date:7/26/2017					
Notes: 2' feet vertical cut at waterside levee toe from wavewash

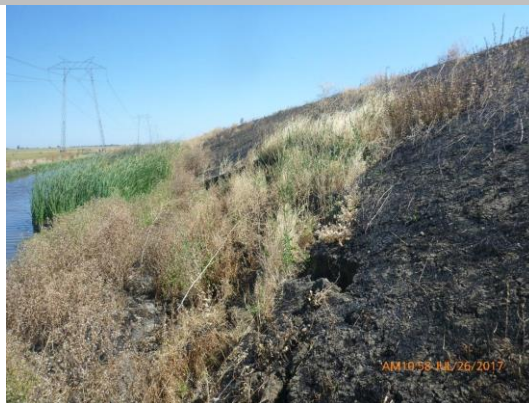
Photo 3 of 3 : SP_2019_RD2068_193_29_20190311_00011.jpg

LM Start	4.39	Rating **	A/W	Issue No.	29 (cont)
LM End	4.40	Issue Type +	Ma	Location *	LS
Category	Supplemental			GPS Latitude/Longitude	
				Start	End
Item	2017 Storm Damage			38.344900 °	38.344800 °
				-121.694000 °	-121.694000 °
DWR ID	DWR_RD2068_01_f_2017_29				
Comment Code					
Inspector Comment					
Levee Evaluation Comments					
Description:The damage consists of scour, cracking, and sloughing of the lower landside levee slope approximately 30 feet in length along the west (right) bank of Shag Slough (Yolo Bypass). See attached pages for photos.					
Site ID No:464					
Site Designation:LMA-291					
Repair Type: Stability					
Rating:Serious					
Field Date:7/26/2017					
Notes: 2' feet vertical cut at waterside levee toe from wavewash

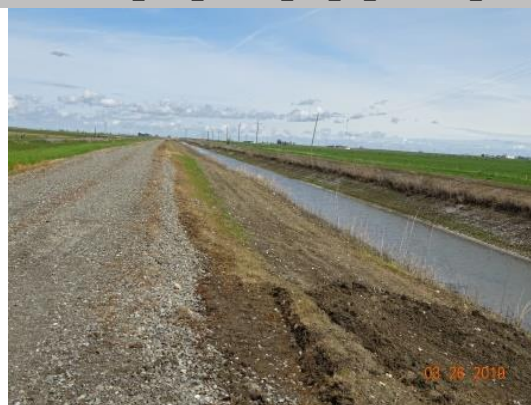
Photo 1 of 1 : SP_2019_RD2068_194_12_20190326_00010.jpg

LM Start	0.02	Rating **	A	Issue No.	12
LM End	2.23	Issue Type +	Ma	Location *	LS
Category	Earthen Levee			GPS Latitude/Longitude	
				Start	End
Item	Vegetation			38.358405 °	38.387065 °
				-121.740403 °	-121.726167 °
DWR ID	DWR_RD2068_02_s_2019_12				
Comment Code					
V1 : Control annual grass and weeds on the levee slopes and easements.					
Inspector Comment					
Annual vegetation is well maintained on the landside slope.

View looking upstream at the well maintained vegetation on the landside slope (Spring 2019).

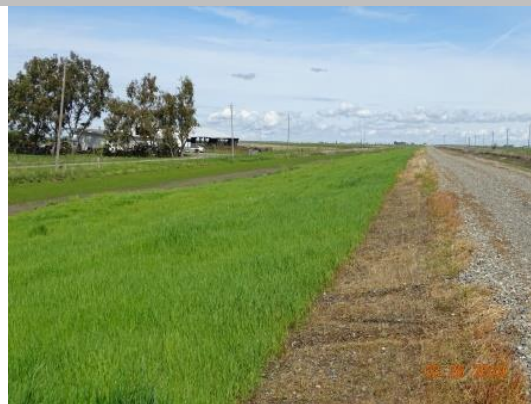
Photo 1 of 1 : SP_2019_RD2068_194_13_20190326_00009.jpg

LM Start	0.02	Rating **	A	Issue No.	13
LM End	2.23	Issue Type +	Ma	Location *	WS
Category	Earthen Levee			GPS Latitude/Longitude	
				Start	End
Item	Vegetation			38.358405 °	38.387065 °
				-121.740403 °	-121.726167 °
DWR ID	DWR_RD2068_02_s_2019_13				
Comment Code					
V1 : Control annual grass and weeds on the levee slopes and easements.					
Inspector Comment					
Annual vegetation is well maintained on the waterside slope.

View looking upstream at well maintained vegetation on the waterside slope (Spring 2019).

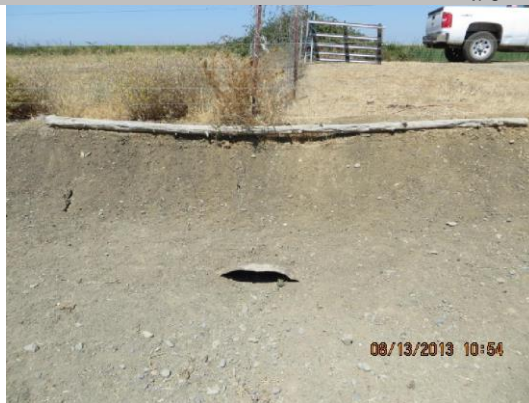
Photo 1 of 1 : UCIP_SP_2019_42725_29680.jpg

LM Start	3.15	Rating **	M	Issue No.	24
LM End	3.15	Issue Type +	Ma	Location *	
Category	Supplemental			GPS Latitude/Longitude	
				Start	End
Item	DWR UCIP LMA Responsibility			38.397933 °	38.397933 °
				-121.716406 °	-121.716406 °
DWR ID	19352

Comment Code					
Inspector Comment					
FS_ID:42725					
DS_ID:19352					
EP_NO: 10164					
Repair Type: Non-Urgent					
Crossing Status: Found					
UCIP Comments: 09/14/2017 ABO issued as Permit No. 10164 defines the 48-inch pipe as a drainpipe. (DWR UCIP - O. Magana)					
08/13/2013 Appears abandoned and if so should be done properly.					
Pipe burried except for small opening. (DWR UCIP - W. Wylie)					
FIELD_STRUCT_DESC: *ABANDONED* 48-inch corrugated metal drainage pipe through the levee, 4 feet below the crown. (48-inch pipe [HLM 3.20] authorized under Automatic Board Order (ABO) issued as Permit No. 10164, 1974 - Reclamation District No. 2068). [Additional Reference(s): DWR Levee Log, 1992. USACE Sacramento O&M Manual 109, April 1962, (HLM 3.20)].					
FS Date: 8/13/2013

Pipe buried but visible at toe of east side of levee.
